Belgrave Road Update

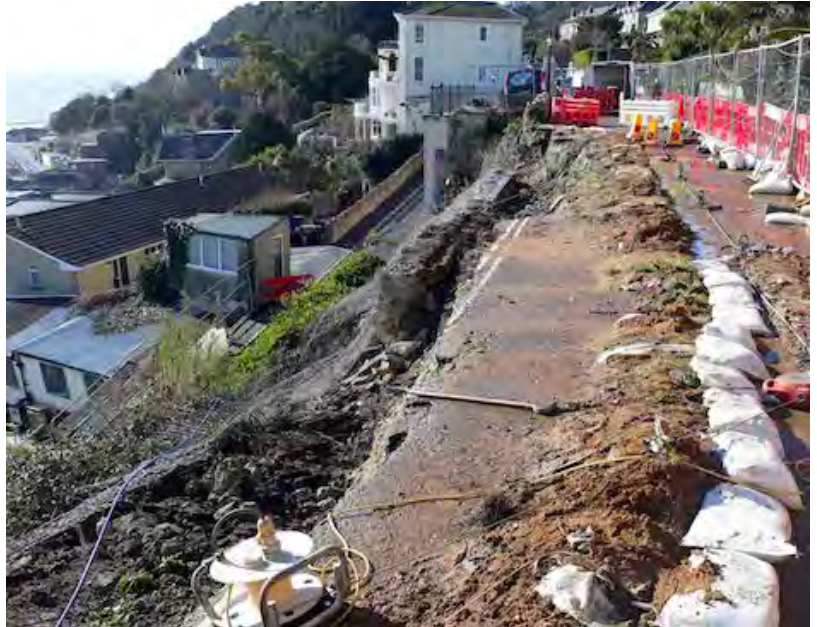
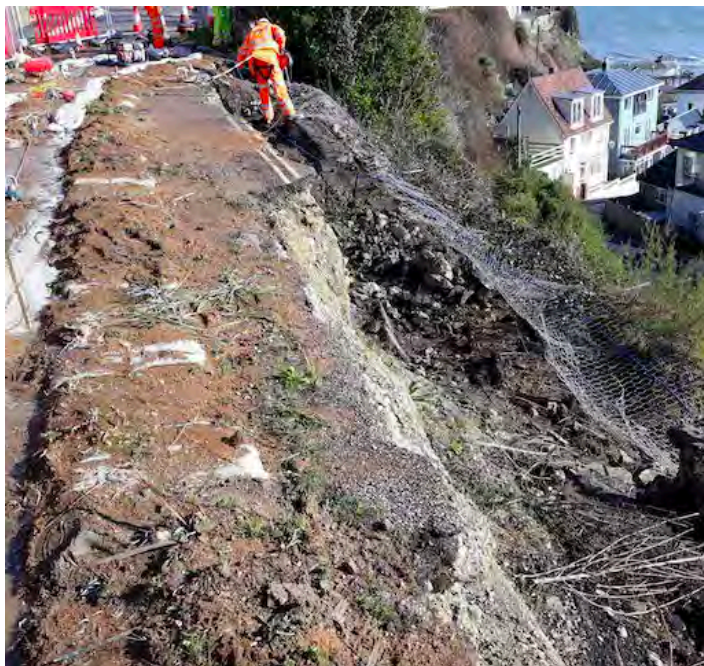
Local company Stoneham Construction has been working on site to strengthen the walls either side of the collapsed section. The process for doing this involves drilling soil nails - grouted steel nails - into the natural soil slopes creating a composite mass similar to a gravity retaining wall, which gives them extra strength during the excavation process.

A crane has also been used on site to remove a large section of the collapsed wall to make the area safer for those working on the dismantling of the remaining sections.

This dismantling work will continue into March, with sections being removed and disposed of off-site.

Next month, following the dismantling of the collapsed wall, we will take steps to temporarily stabilise the sections of the exposed embankment face with further soil nails and spray concrete as we begin the process of rebuilding the walls.
