Belgrave Road Update

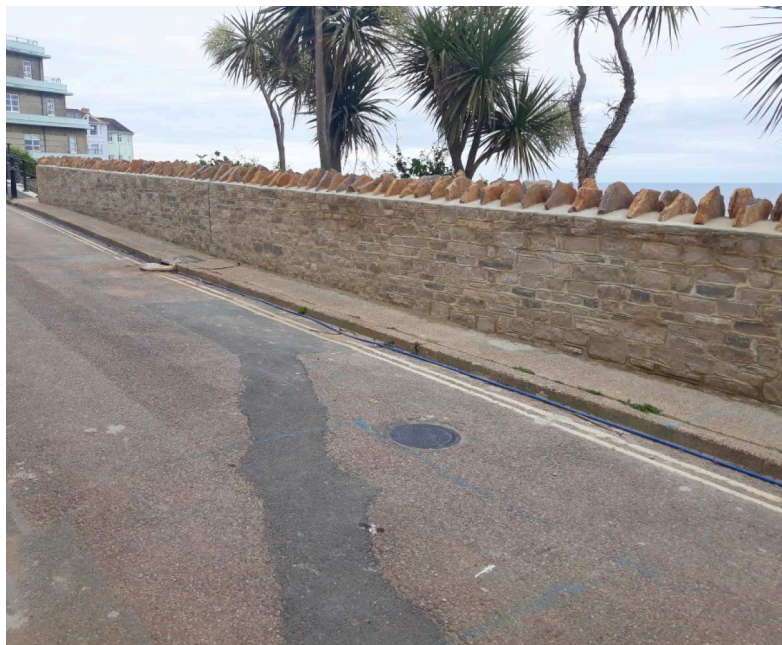
In the last month we have also completed the 25 metre section of parapet wall to the east of the site (see photo opposite) and consequently we have been able to remove the security fencing at this location.

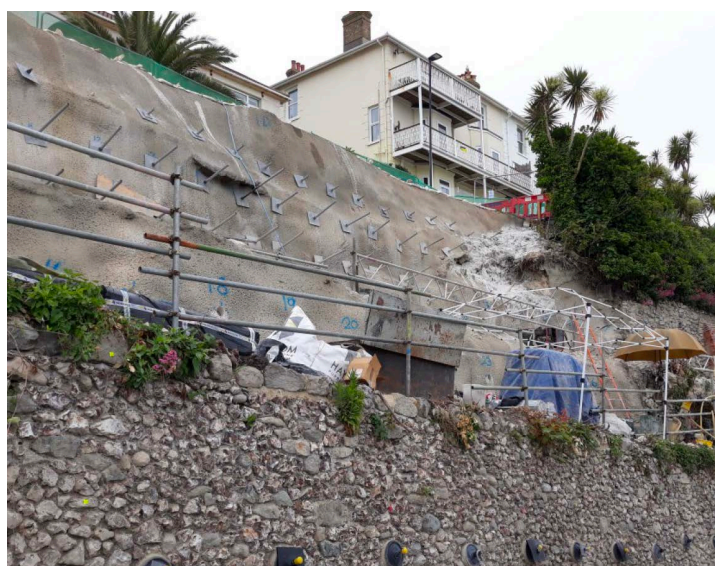
Work has been continuing on site at Belgrave Road with the exposed slope now having been stabilised from top to bottom with spray concrete and soil nails. We have applied over 130 soil nails to the site to date to help stabilise this area.

Nail head plates (which you can see protruding from the slope in the picture below) have also been installed across the site. These will remain in situ and will eventually be covered by the masonry and cladding that will form the newly built wall.
